Characterization of Single-Crystal Turbine Blades by X-Ray Diffraction Methods

Keywords: CMSX-4, superalloys, X-ray topography, turbine blade

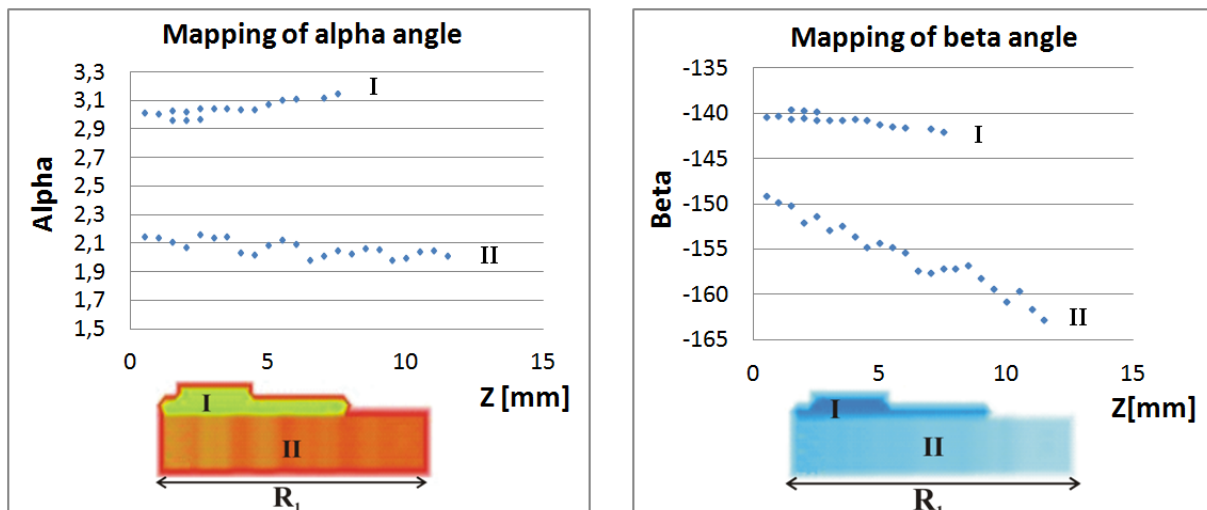
The X-ray diffraction mapping conducted on the EFG diffractometer was obtained only from region R1, the diffractometer was not able to collect data from X-ray reflexes in R2. The results revealed the same subgrain structure on both maps alpha and beta angle. The misorientation between subgrain (α) was about 0,8 degree which was confirmed by both X-ray topography and X-ray diffraction mapping methods. The beta angle shows continuous decreasing of around 22 degree within subgrain II. It was caused by the rotation of dendrites along the Z axis. The bending of the X-ray topography images could also be the reason of that rotation. The topogram shows bending (Fig. 2a in respect to the Z axis) which was not caused by the real shape of the sample (Fig. 2b).

Fig. 4. α and β angle changes along the Z axis determined by X-ray diffraction mapping.
